ANNUAL REPORT
TOWN OF CANTON
JANUARY – DECEMBER 2023

PREPARED BY:
Atlas
290 Roberts Street-Suite 301
East Hartford, Connecticut 06108

2023 MS4 ANNUAL REPORT

MS4 General Permit
Town of Canton 2023 Annual Report
 Permit Number GSM 000091
 January 1, 2023 – December 31, 2023
 Primary MS4 Contact: Robert J. Martin, Director of Public Works
 860-693-7863, rmartin@townofcantonct.org

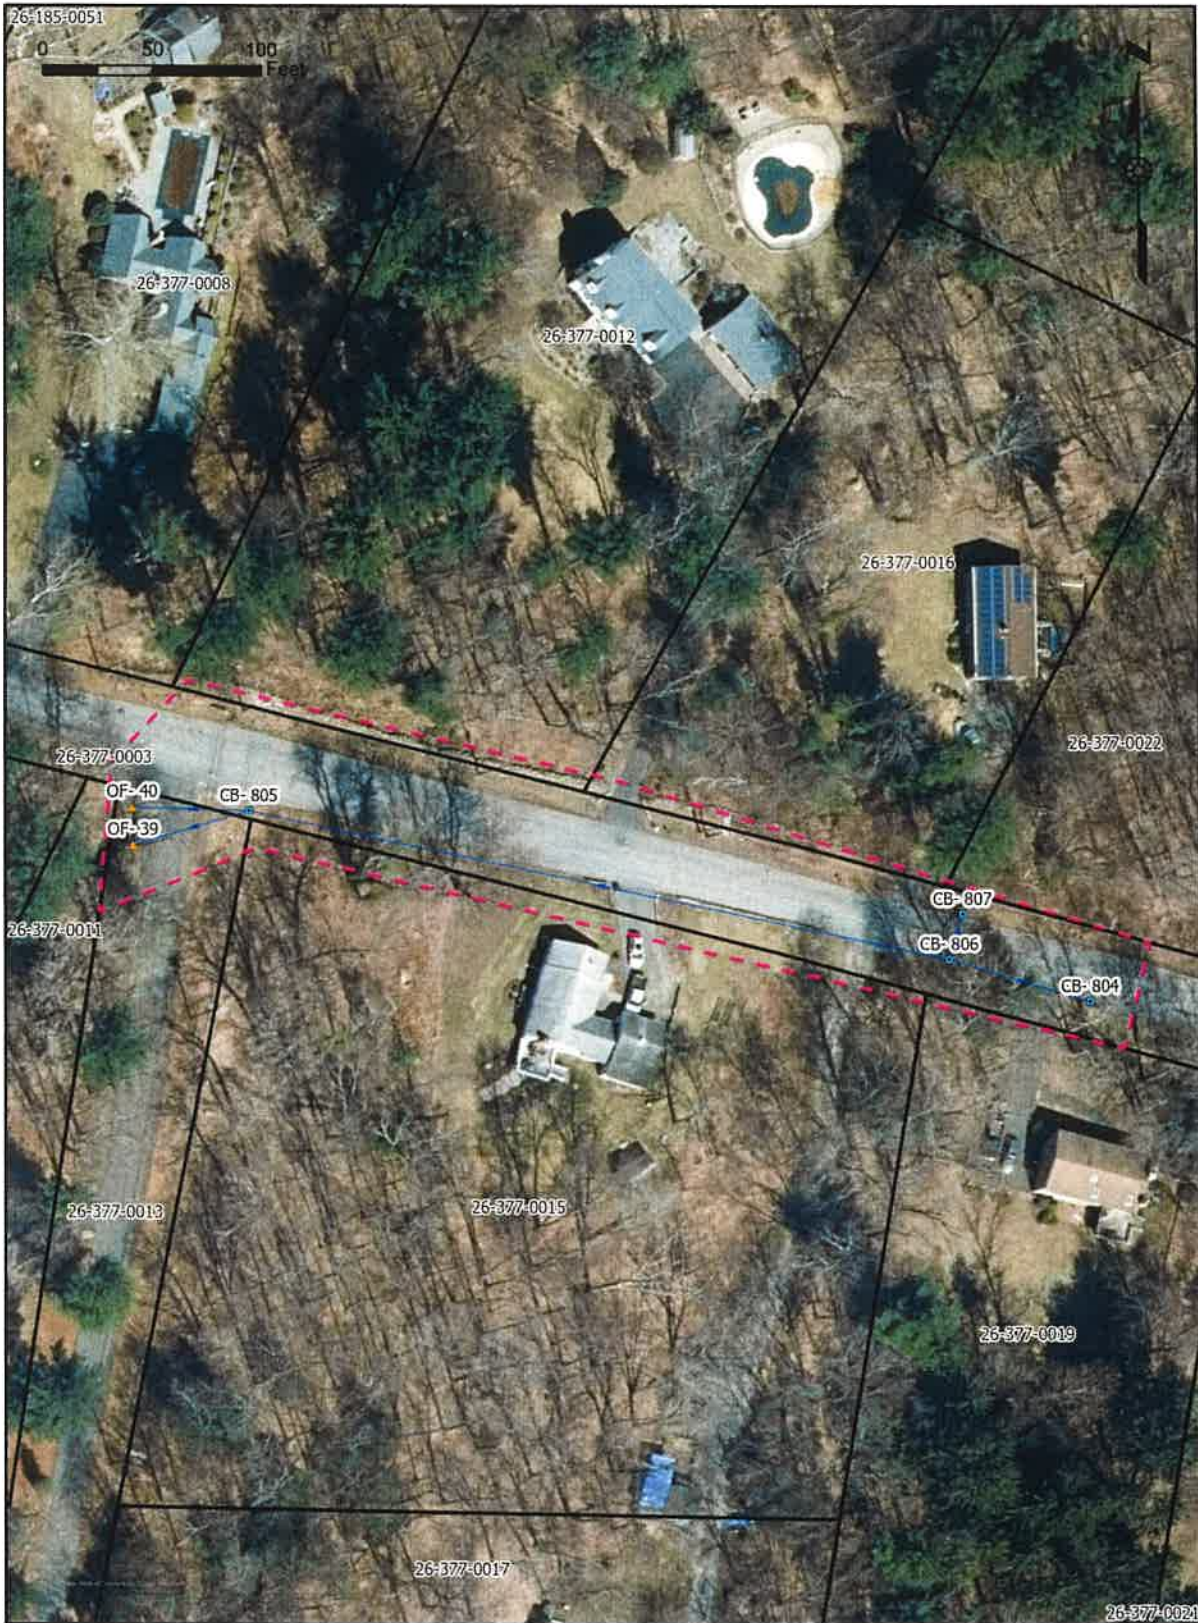
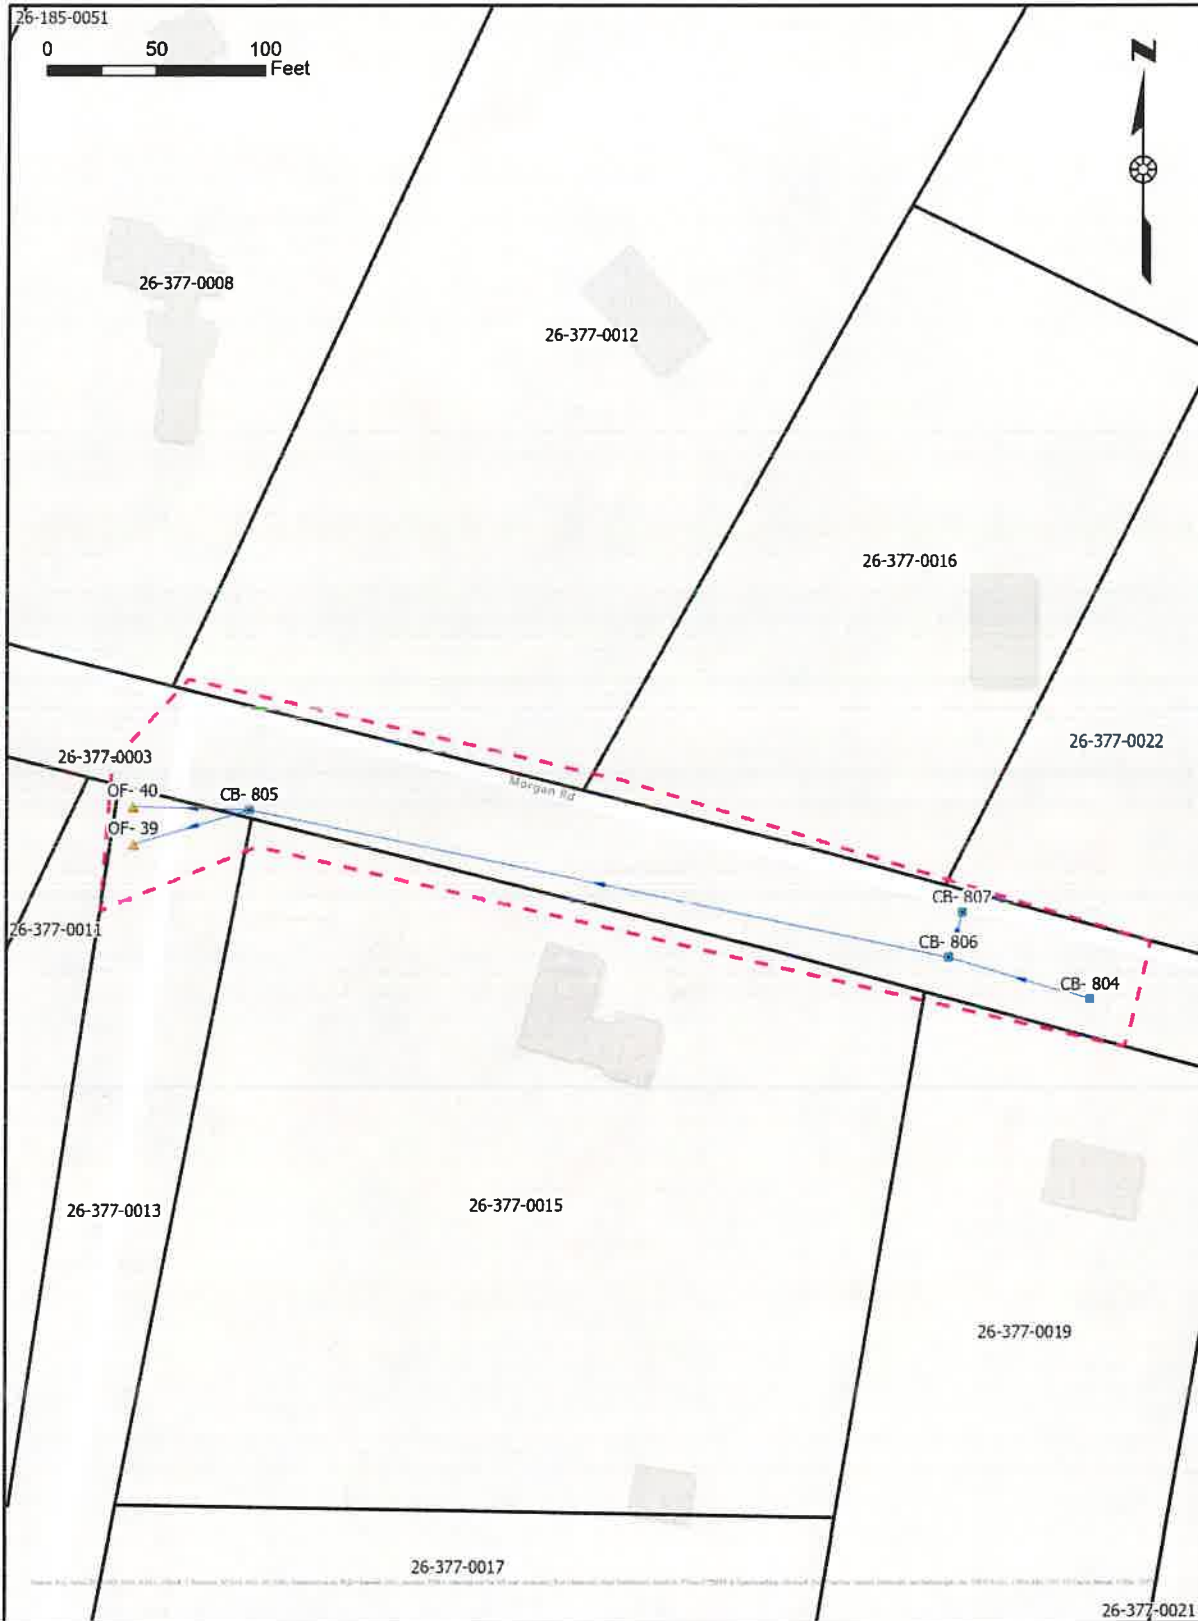
2023 Annual Report
 OF-39/40 Catchment
 Investigation

Any additional observations?	X		Foam was observed in CB-804 where an unidentified pipe from 19 Morgan Road property was present.

Catch Basin ID	Observations
CB-804	The catch basin was observed to be in good condition with an unidentified pipe connected to 19 Morgan Road discharging into it. Foam was observed on the surface of the discharge.
CB-806	The catch basin was observed to be in good condition and receives discharge from CB-804.
CB-807	The catch basin was observed to be in good condition and discharges stormwater to CB-806.
CB-805	The catch basin was observed to be in good condition and receives discharge from CB-806 and discharges to OF-39 across Camille Lane.
OF-39	The Outfall to the left of OF-40. This outfall collects stormwater discharge from CB-805.
OF-40	The Outfall to the right of OF-39. This outfall collects stormwater runoff coming from the left side of Morgan Road via curb inlet and drainage pipe.

Rationale: Atlas staff noted there were additional pipes discharging into CB-804. Samples collected from OF-40 indicated high levels of Total Coliforms and E. Coli over the past three years. Based on these observations, it is possible there is illicit discharges coming from the pipes. These pipes seem to be connected to the residential houses on Camille Lane, potentially from the house at 11 Camille Lane. In addition, septic failure data was obtained. In 2021, a failing septic tank was replaced 0.1 miles from OF-39 and OF-40. In 2023, a sewage overflow occurred 0.2 miles from the outfalls, with the leaching field needing to be replaced afterwards. These and other potentially aging septic systems may be contributing to the elevated bacteria levels in these outfalls.

Atlas recommends sampling all four catch basins and assessing if there is runoff coming from the additional pipes during a heavy rain event to determine if OF-40 is impacted by illicit discharges.

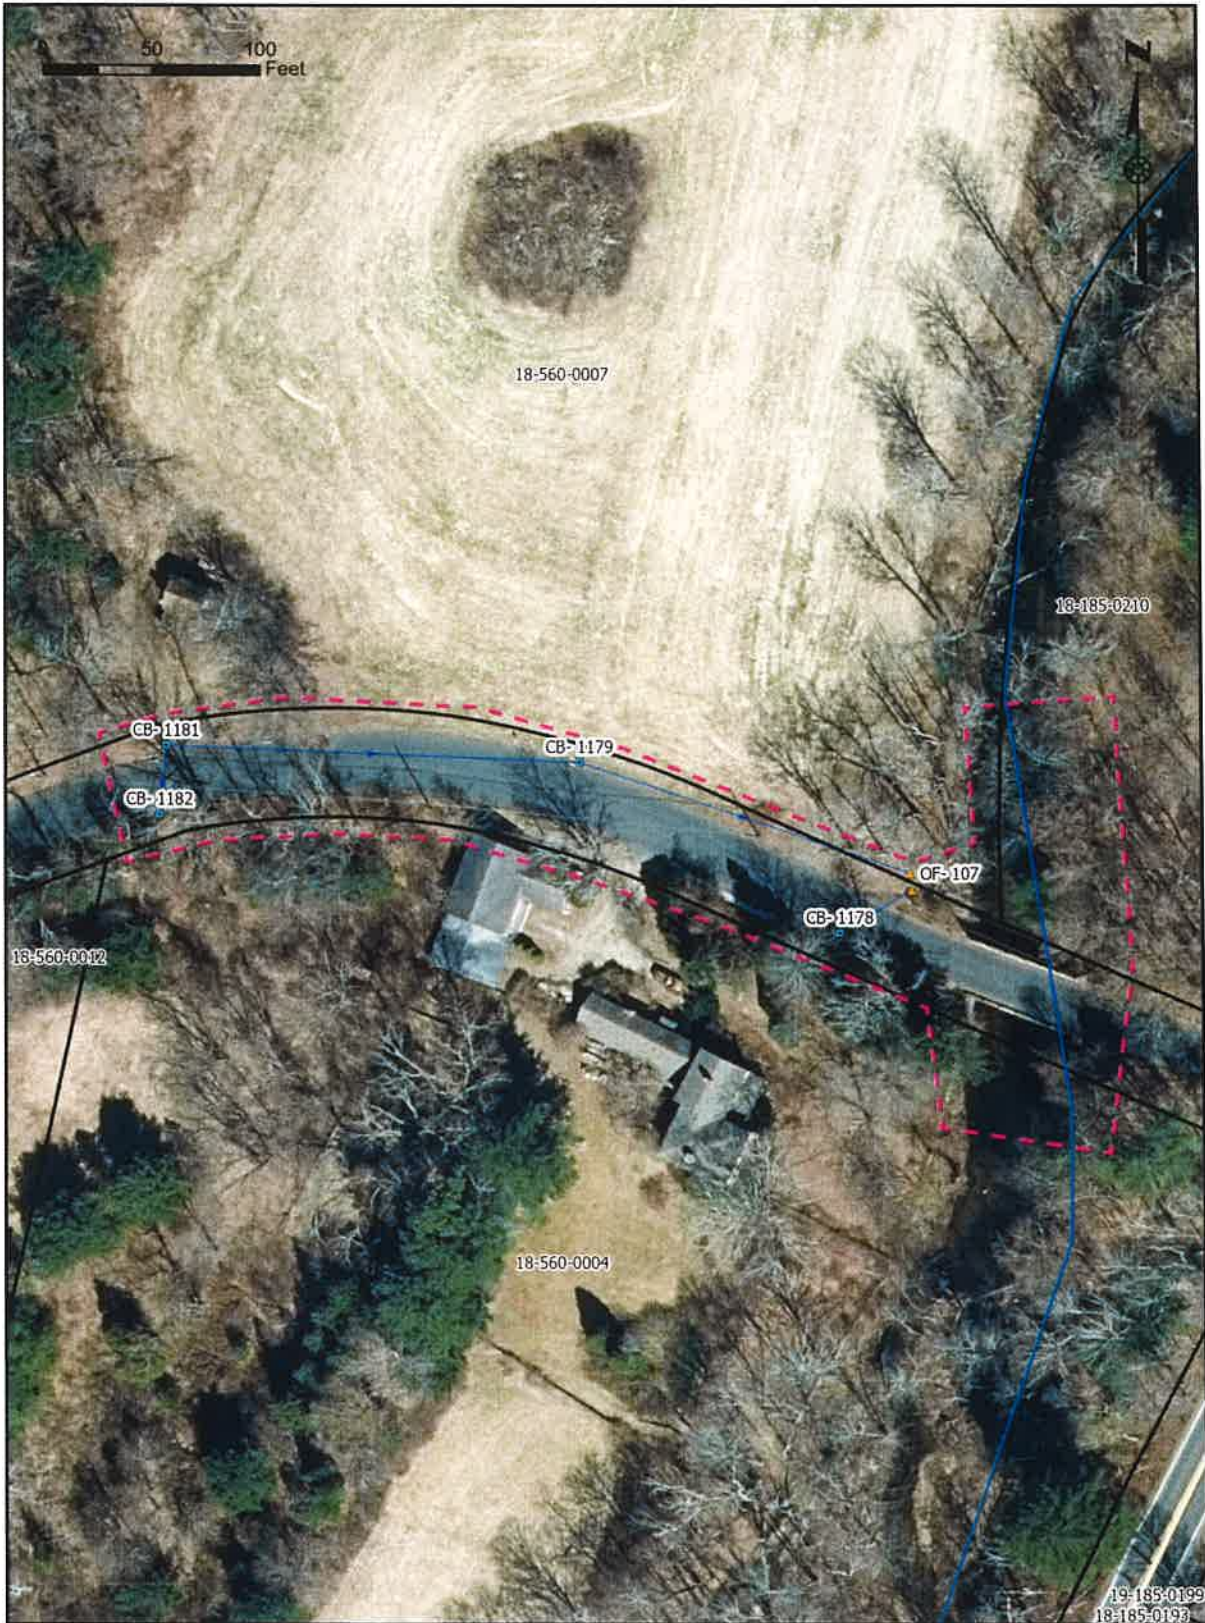
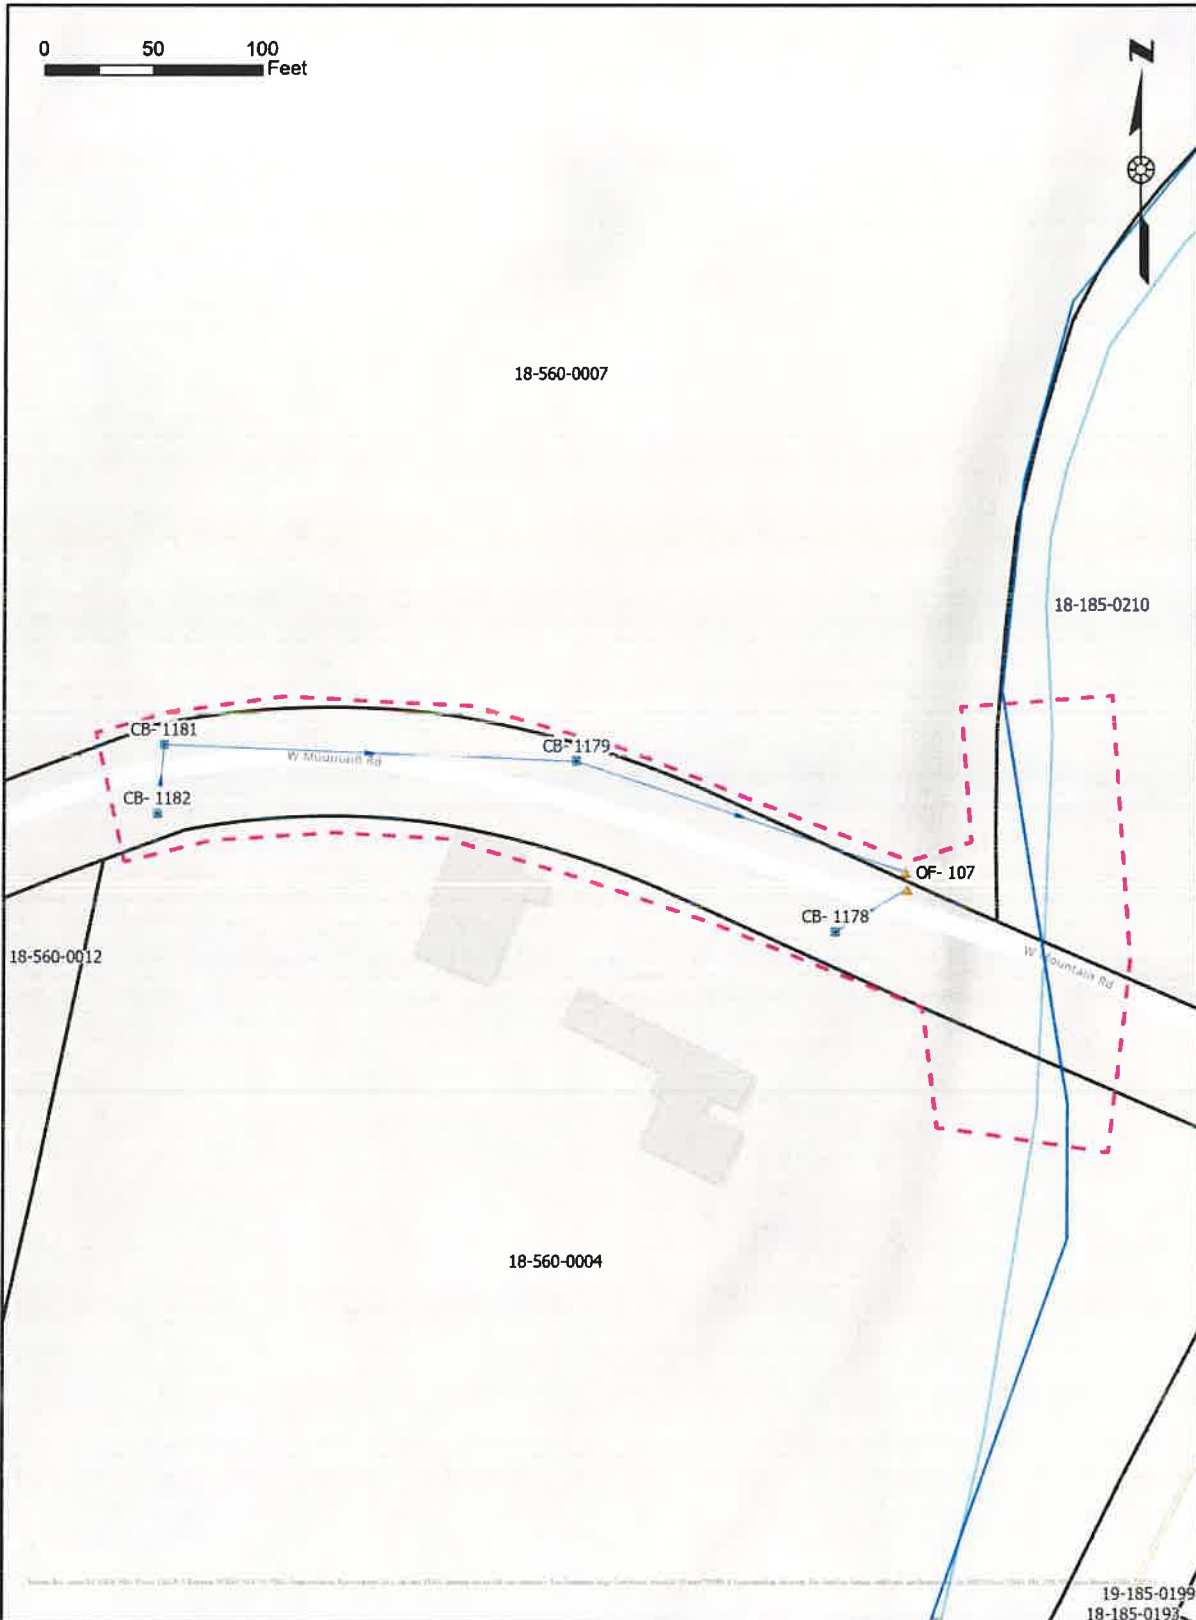
Town of Canton
 2023 Annual Report
 OF-107/108 Catchment
 Investigation

Rationale: Atlas staff noted the parcels near the catch basins were mostly wooded. Samples collected from OF-107 and OF-108 indicated high levels of Total Coliforms and E. Coli over the past three years. Based on these observations, it is possible that runoff from West Mountain Road is contaminated. Atlas recommends sampling all four catch basins and assessing where the bacteria could be originating from during a heavy rain event. In addition to this an investigation, septic failure data was obtained. An aging septic tank was replaced on West Mountain Road, approximately 0.7 miles from OF-107 and OF-108. It is possible that this and other aging septic systems that have not yet been replaced in the area are contributing to the elevated bacterial levels from the outfalls.
