MS4 Annual Report Transmittal Form

2022 MS4 ANNUAL REPORT

Town of Canton, Connecticut

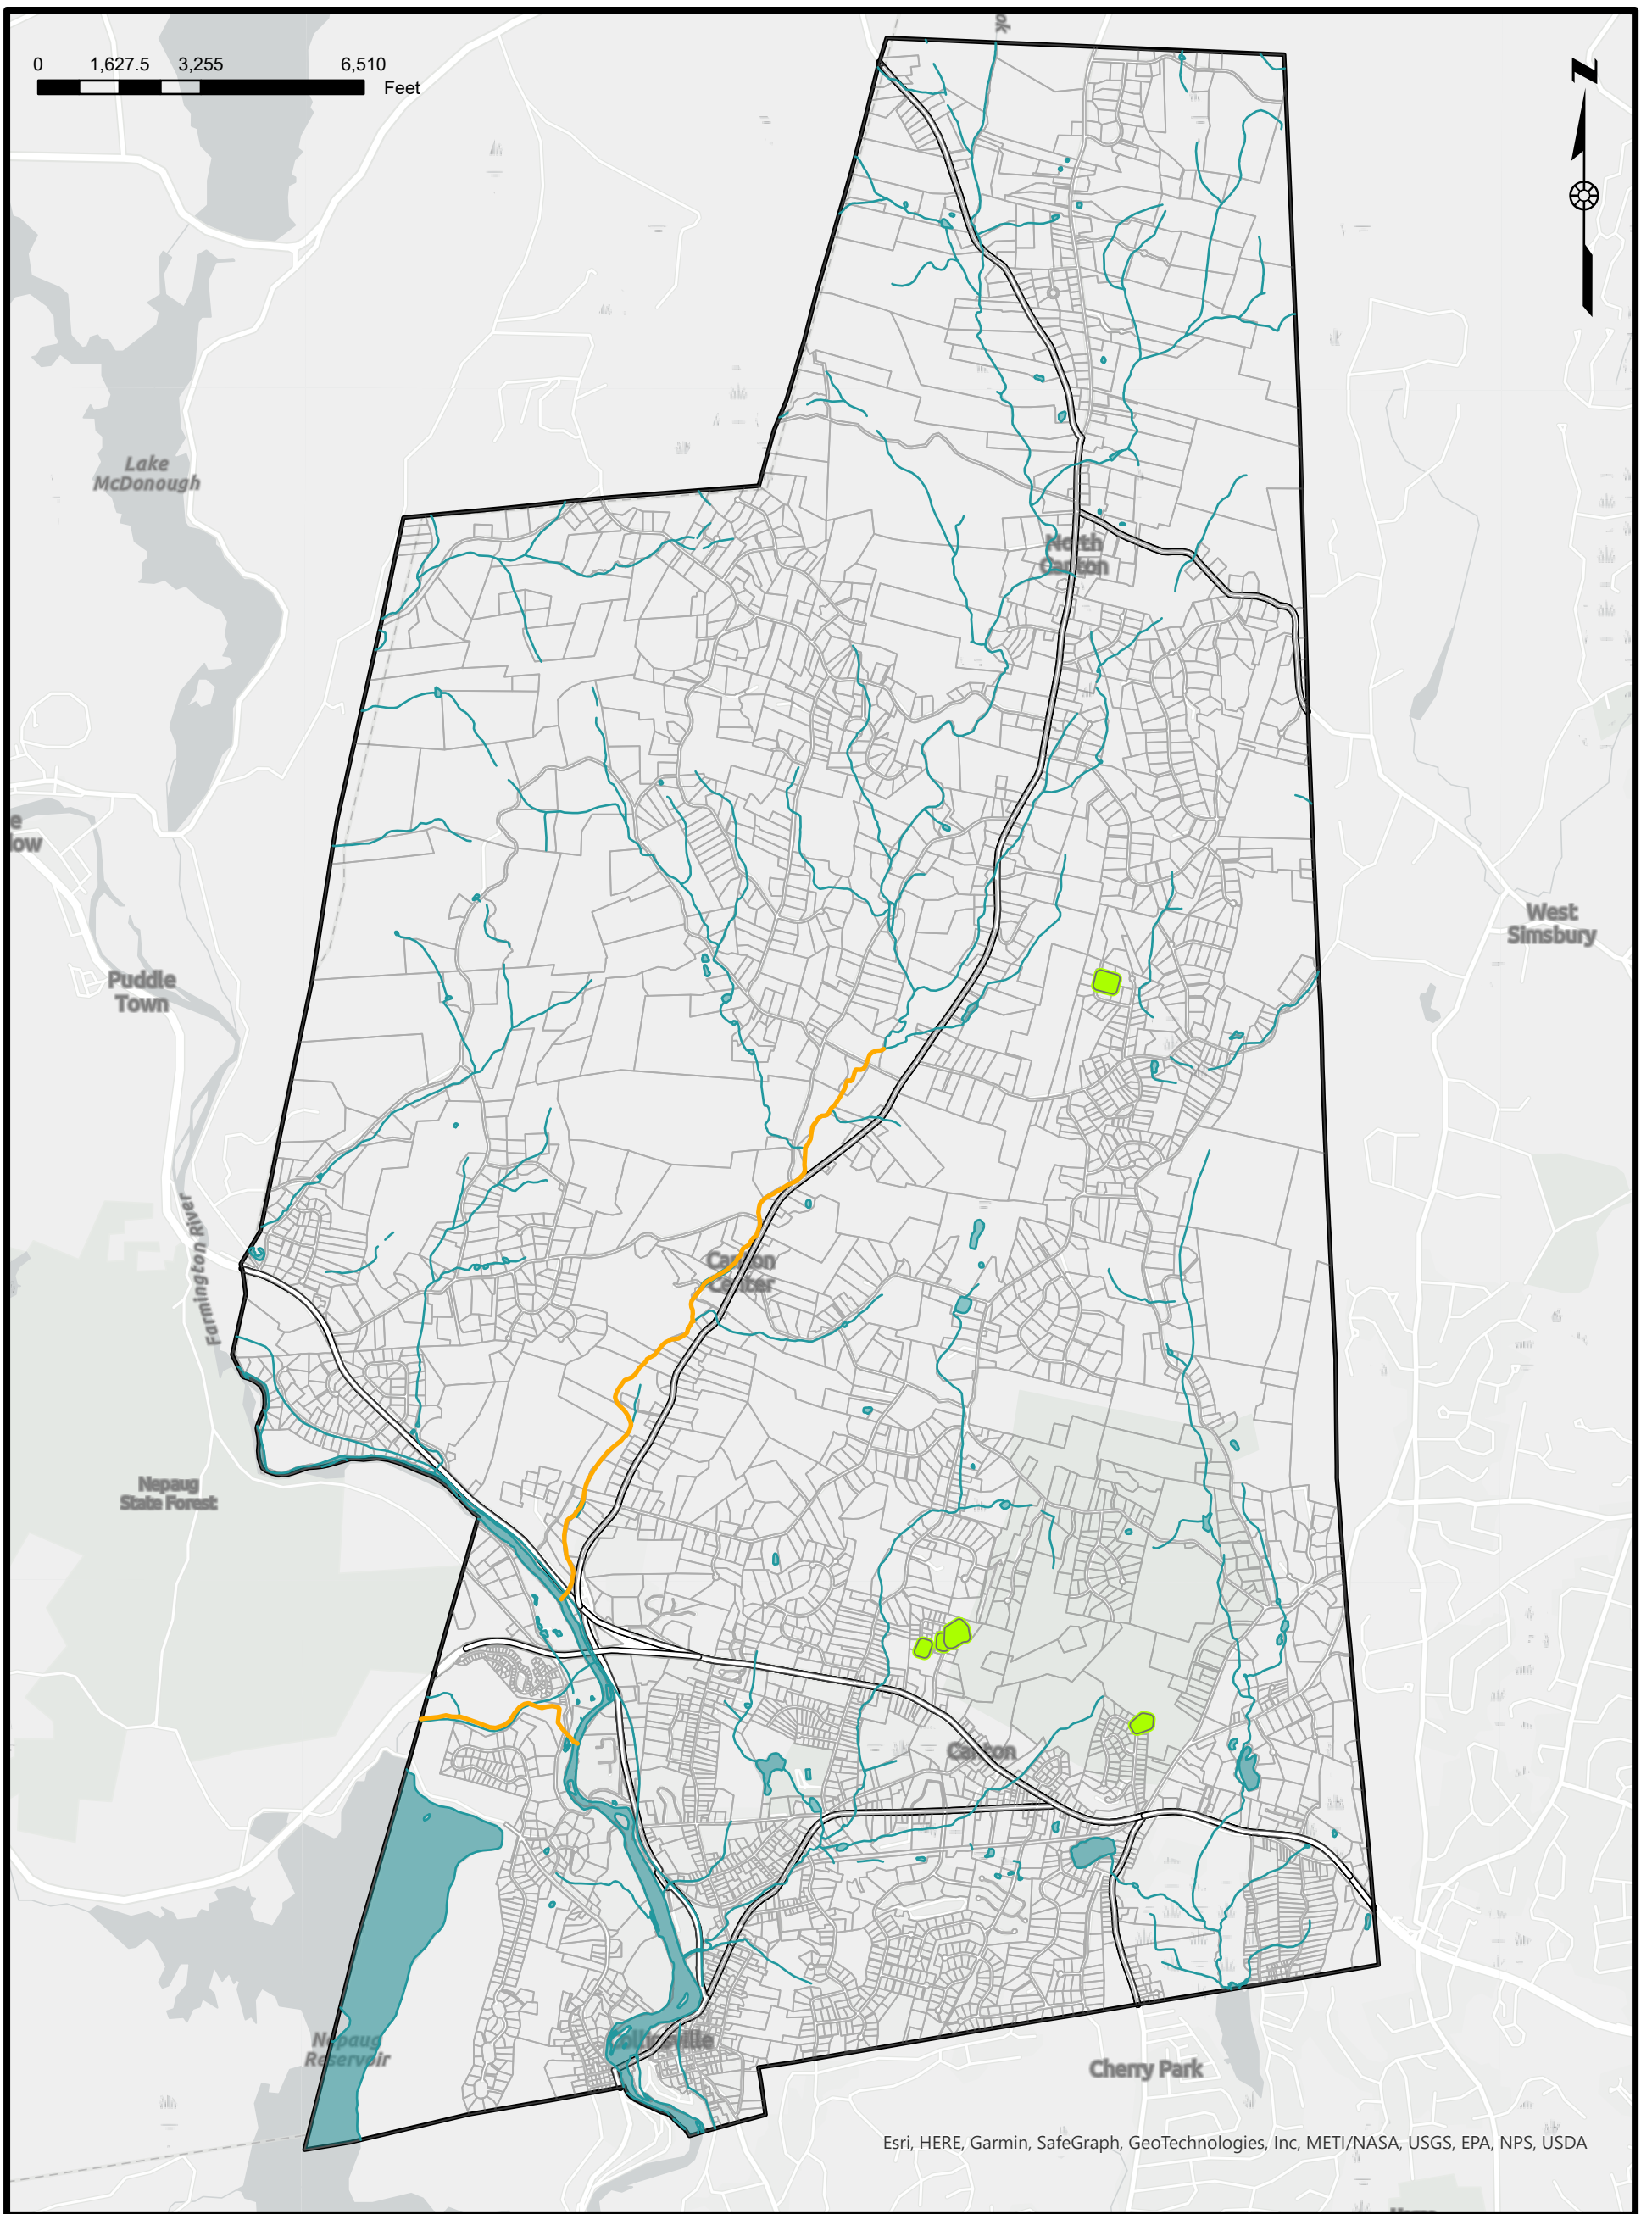
2022 Septic Failures

| 2022 | | | | | | |
|---|---|---|---|---|---|---|
| 35 Trailsend Drive | 4/8/2022 | Unnamed Brook | Unknown | The septic tank was reported in poor condition. | The septic system was evaluated by the FVHD, and a permit for tank replacement was granted. An engineering plan is shown for the installation of a new 1,000-gallon septic tank. | None. |
| 9 Noja Trail | 5/10/2022 | Unnamed Brook | Unknown | Out-of-level and cracked at outlet side. | A 1,250-gallon septic tank was installed, and the existing tank was abandoned. Other corrective measures were listed as the installation of a 6-hole D-Box. | None. |
| 24 Bristol Drive | 6/10/2022 | None. | Unknown | Not stated. | An application for a site evaluation of the septic system was requested in May 2022. The site was evaluated, and the evaluation found that the system could be repaired; however, system failures were not listed. Recommendations listed included the proper abandonment of the old septic tank and other hollow structures, installation of a new septic tank with an outlet baffle filter, and to provide a total of 495 square feet of leaching area. | None. |
| 50 Bristol Drive | 7/22/2022 | None. | Unknown | Breakout | A site evaluation was completed due to septic breakout at this property (See 2021). Subsequently, a new septic tank was installed. The leaching system was found non-compliant relative to the MLSS requirements, however, an exception was granted, as it was unlikely to result in a health hazard. | None. |

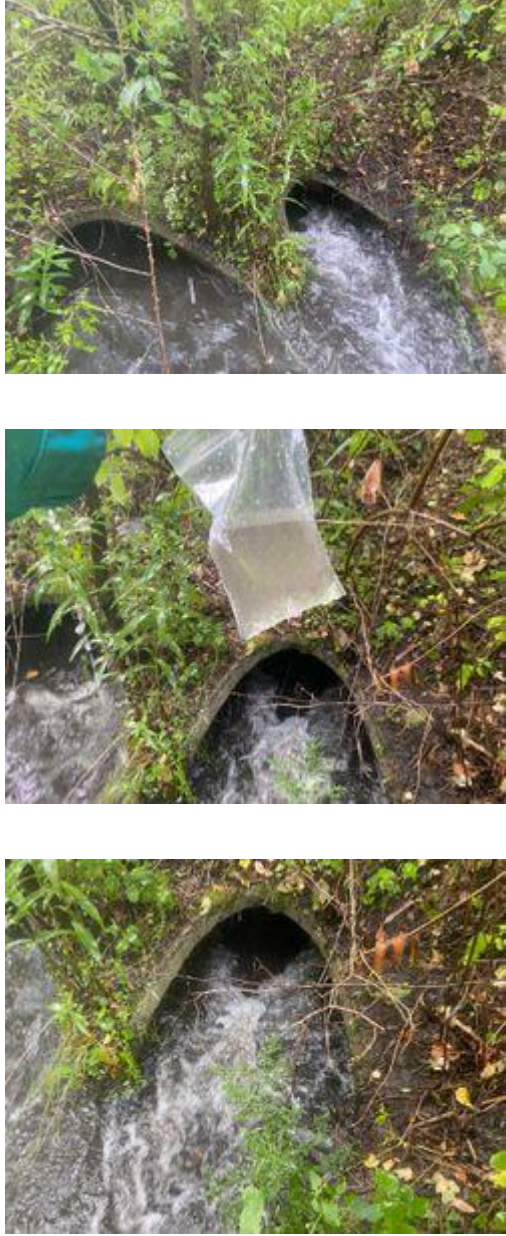
| Location (Lat long/ street crossing /address and receiving water) | Date and duration of occurrence | Discharge to MS4 or surface water | Estimated volume discharged | Known or suspected cause / Responsible party | Corrective measures planned and completed (include dates) | Sampling data (if applicable) |
|--|---|---|---|--|--|---|
| OF-105 | 4/13/2021 | Yes | Unknown | TBD | Pending SSOs investigation. Sampling data was indicative of elevated concentrations of bacteria; however, it is unclear whether the bacteria concentrations are indicative of a septic failure or natural background conditions. | Refer to Part II: Impaired Waters Investigation and Monitoring of this report. |
